MISCELLANEOUS PAPER S-73-52

**CONDITION SURVEY  
BANGOR INTERNATIONAL AIRPORT  
BANGOR, MAINE**

June 1973

Conducted by U. S. Army Engineer Waterways Experiment Station  
Soils and Pavements Laboratory  
Vicksburg, Mississippi

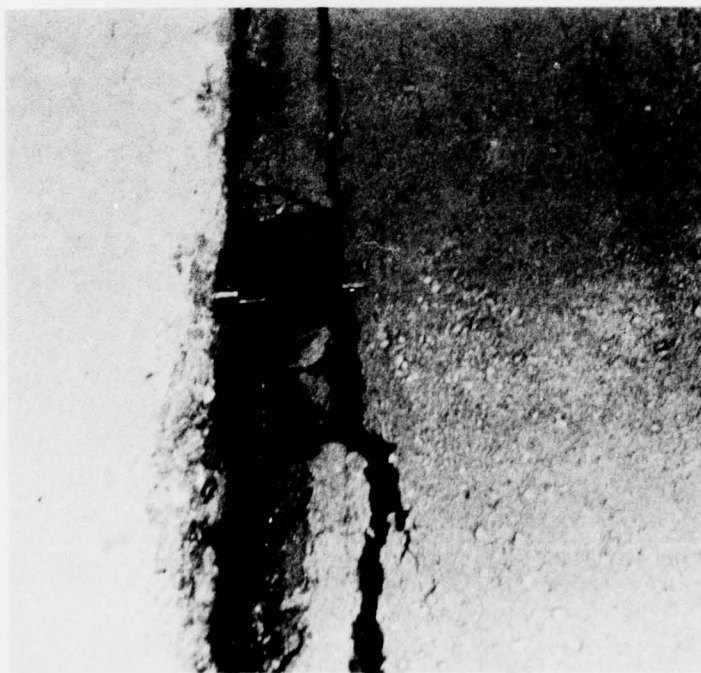
11. The 19-in. PCC pavement of the north connecting taxiway (feature T1A) was in excellent condition. The NW end of the parallel taxiway (feature T2A), which is 19-21-19-in. PCC pavement, was in only fair condition. The major defects in this feature were longitudinal cracks, and the minor defects were principally longitudinal shrinkage cracks that will probably develop into major defects. The 19-in. PCC pavement in the parallel taxiway at the intersection of taxiway L (feature T3A) was in a poor to failed condition. This section had 21 slabs that contained longitudinal cracks; 15 of the 16 slabs in the center lane contained longitudinal cracks. Feature T4A, which is asphaltic concrete (AC), was in only fair condition. This area had several contraction cracks and contained some slight rutting. Feature T5A was also in a poor to failed condition. Of 165 slabs in this area, 106 contained at least one major defect. Only two slabs in the 17-in. pavement adjoining the apron did not have a major defect. The center lane, which is 19-in. pavement, had 42 slabs with major defects, but the west lane (17-in. pavement) had only 11 slabs with major defects. Feature T6A (AC pavement) was in fair condition. The area of the parallel taxiway at sta 20+27 to 24+02 was in very good condition. Plate 3 shows a comparison of defects (i.e., between those observed in this survey and those in the 1959 and 1961 surveys) in the NW end of the NW-SE parallel taxiway and in the north connecting taxiway. Feature T8A was in excellent condition; this area had recently been overlaid (photo 1). The south connecting taxiway (feature T9A), which is 17-19-17-in. RPCC pavement, was in excellent condition. Only 10 major defects were noted, and these cracks were held tightly together by the reinforcement. Photos 2 and 3 show the movement of the south connecting taxiway in the curve near the SE end of the parallel taxiway. Taxiways L and K were in

Photo 2. Close-up of movement of south connecting taxiway in curve near SE end of parallel taxiway

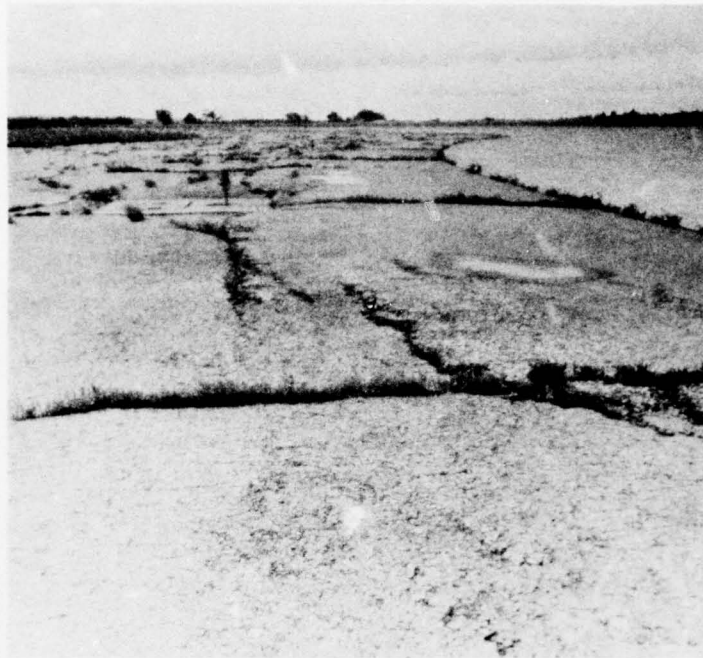
Photo 3. General view of movement of south connecting taxiway

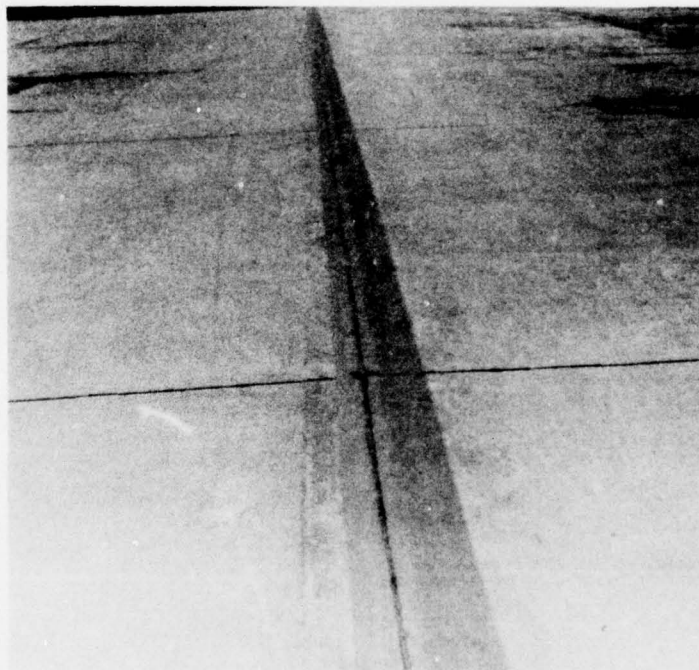
excellent and very good conditions, respectively. Taxiway C to the ANG apron was in good condition. A small section of former AC pavement at the intersection of taxiway C and the apron access taxiway was replaced with a 10-in. PCC pavement with insulation between the base course and the subgrade (photo 4).

31. A test section of insulated rigid pavement (feature T13B) was constructed during the summer of 1971 in taxiway C near the ANG apron. The test section consists of a 10-in. PCC pavement, 16-in. gravel base course, and a 2-in. insulation layer with a minimum 1-in. sand leveling course. As is shown in photo 4, this pavement feature was in excellent condition after a year of service.

Photo 4. Insulated PCC pavement at intersection of taxiway C and ANG apron access taxiway

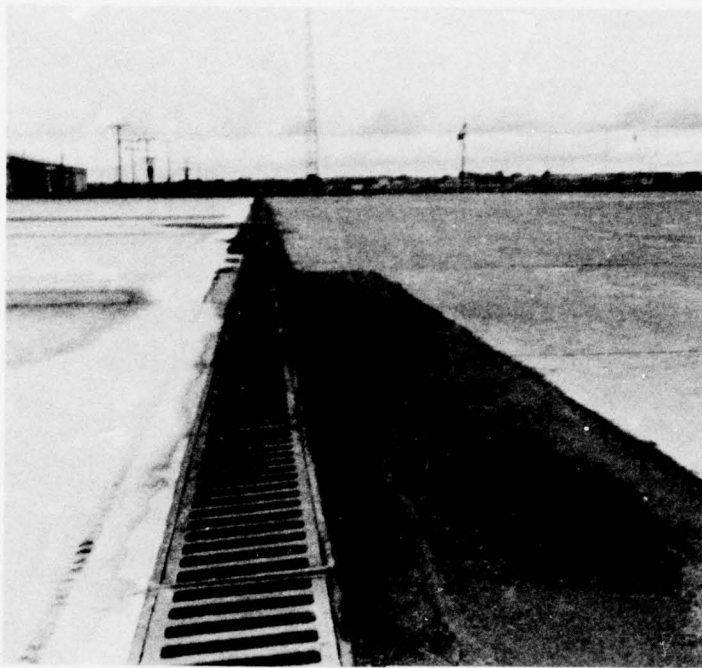
Photo 5. Repair along drain in heavy-load operational apron

performed has consisted of some crack sealing of the shoulder pavements and the repair of the heavy-load operational apron at drainage structures.

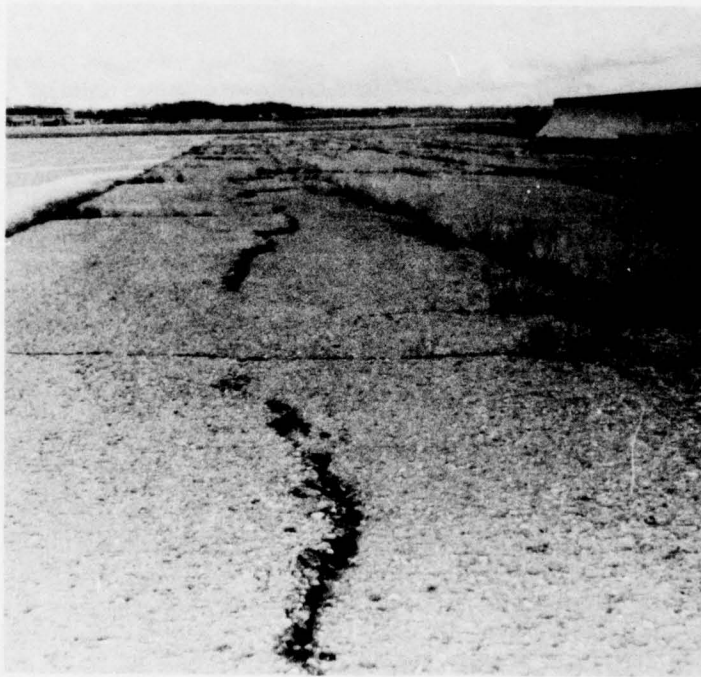
Photo 6. Shoving of shoulder pavement along heavy-load operational apron extension
